Rexroth IndraDrive MPx-02 to MPx-08 and HMV

Troubleshooting Guide

Purpose of Documentation This documentation contains the descriptions of all diagnostic messages implemented in the following firmware versions:

- Drive controller firmware versions MPx-02 to MPx-08 and
- Firmware versions of supply units of type "HMV".

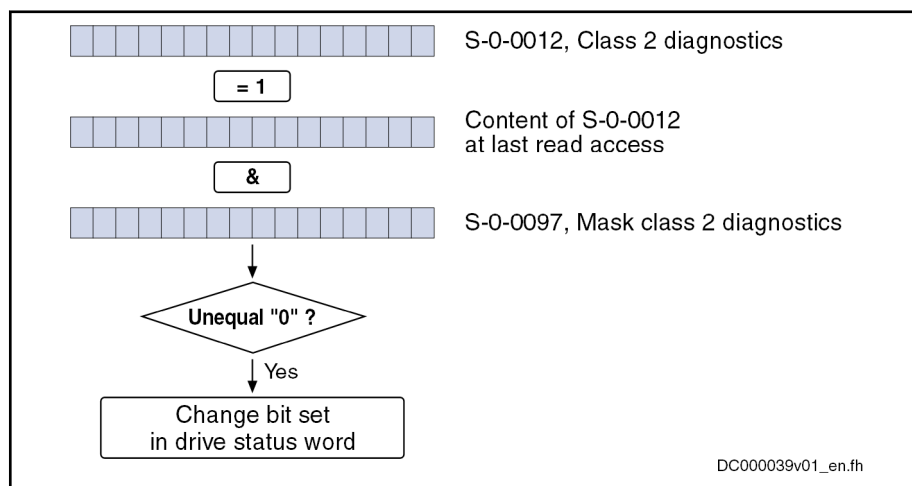
Fig.4-4: Generating the Change Bit of Class 2 Diagnostics

By means of the parameters "S-0-0097, Mask class 2 diagnostics" and "S-0-0098, Mask class 3 diagnostics", it is possible to mask certain bits in terms of their effect on the change bit of the status word (bit 12 or bit 11).

The figure below illustrates the principle of masking by means of an example:

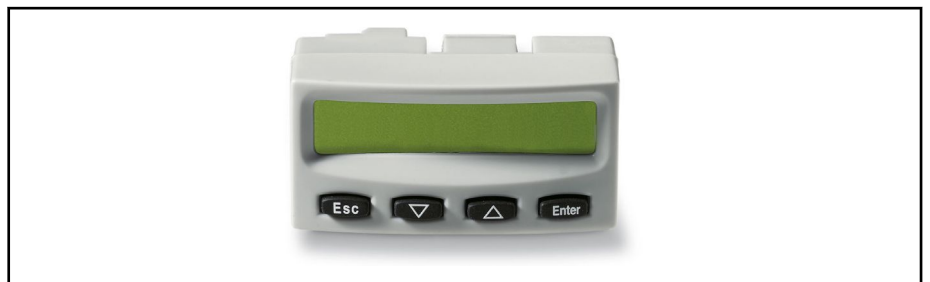
Fig. 4-6: Standard control panel

IndraDrive controllers are equipped with a "control panel"; its front consists of a display with keys located underneath it. The display shows operating states, command and error diagnostics, as well as any pending warnings. The keys are used to enter settings, call information and trigger some commands.

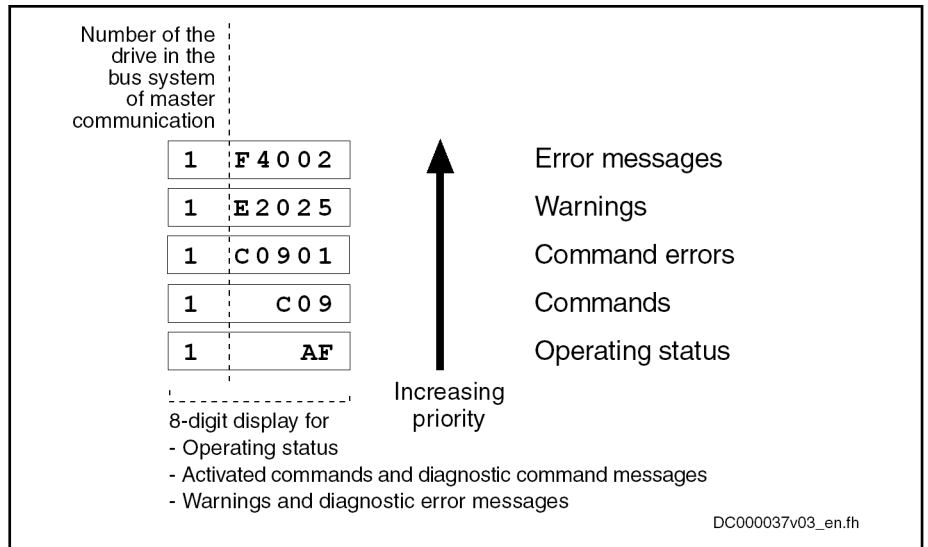
Fig.4-12: Priorities of displays (with sample displays)

The current drive status is displayed with highest priority.

With error messages, warnings and command errors, the diagnostic message text is displayed on the standard display in the form of a marquee text in the standard operating panel, in addition to the flashing diagnostic message number (see also Parameter Description "S-0-0095, Diagnostic message").

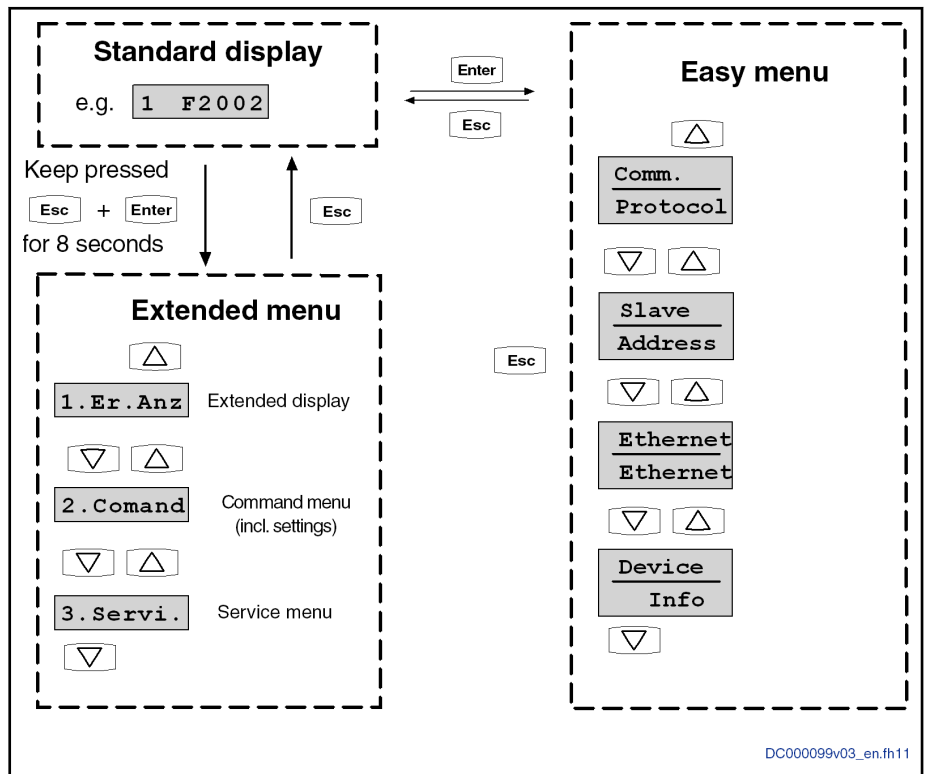
Fig.4-13: Activating the extended display, the command menu and the easy menu

The easy menu can always (without unlocking) be accessed by pressing the "Enter" key.

Simultaneously pressing the "Esc" and the "Enter" keys in the standard display (for 8 s when activated for the first time) accesses the extended menu.

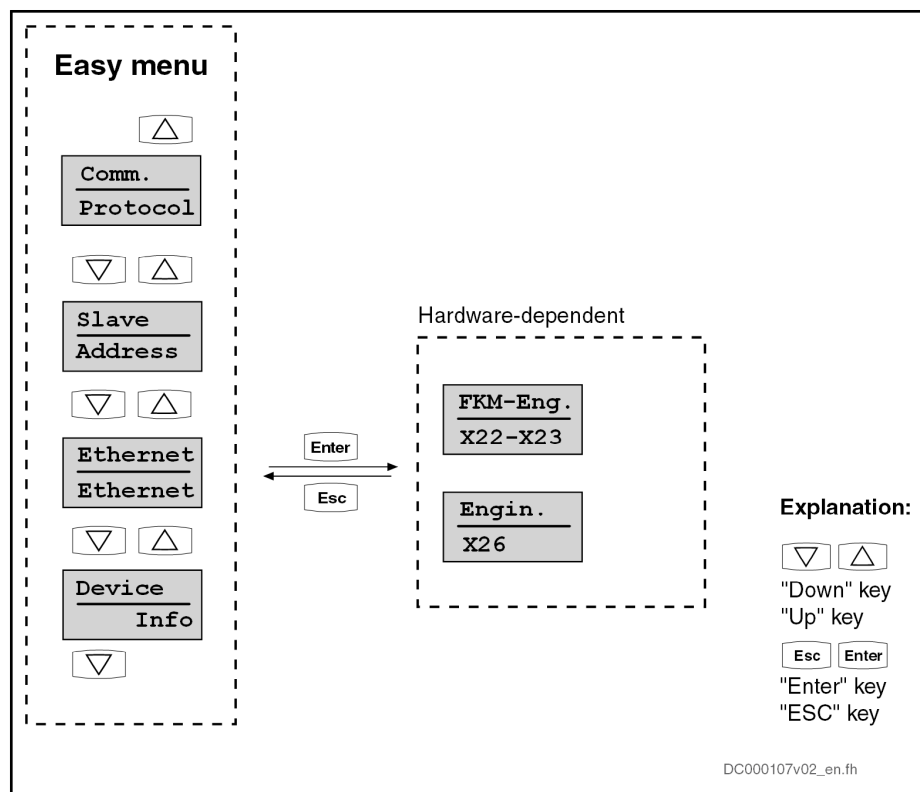
Fig.4-14: Easy menu

Control panel text:	Comment / note:
"Comm.____" "Protocol"	This submenu shows the current field bus protocol and can be changed, if required.
"Slave____" " _Address"	This submenu shows the current drive address. It can be changed, if required.
"Ethernet" "Ethernet"	In this menu the Ethernet connection can be viewed or set. The menu structure below "Ethernet" may vary, depending on the hardware (see "Easy menu" on page 53).
"Device____" " ____Info"	This submenu shows the information on the hardware to be used, e.g. firmware string (S-0-0030). No settings can be made in this submenu.

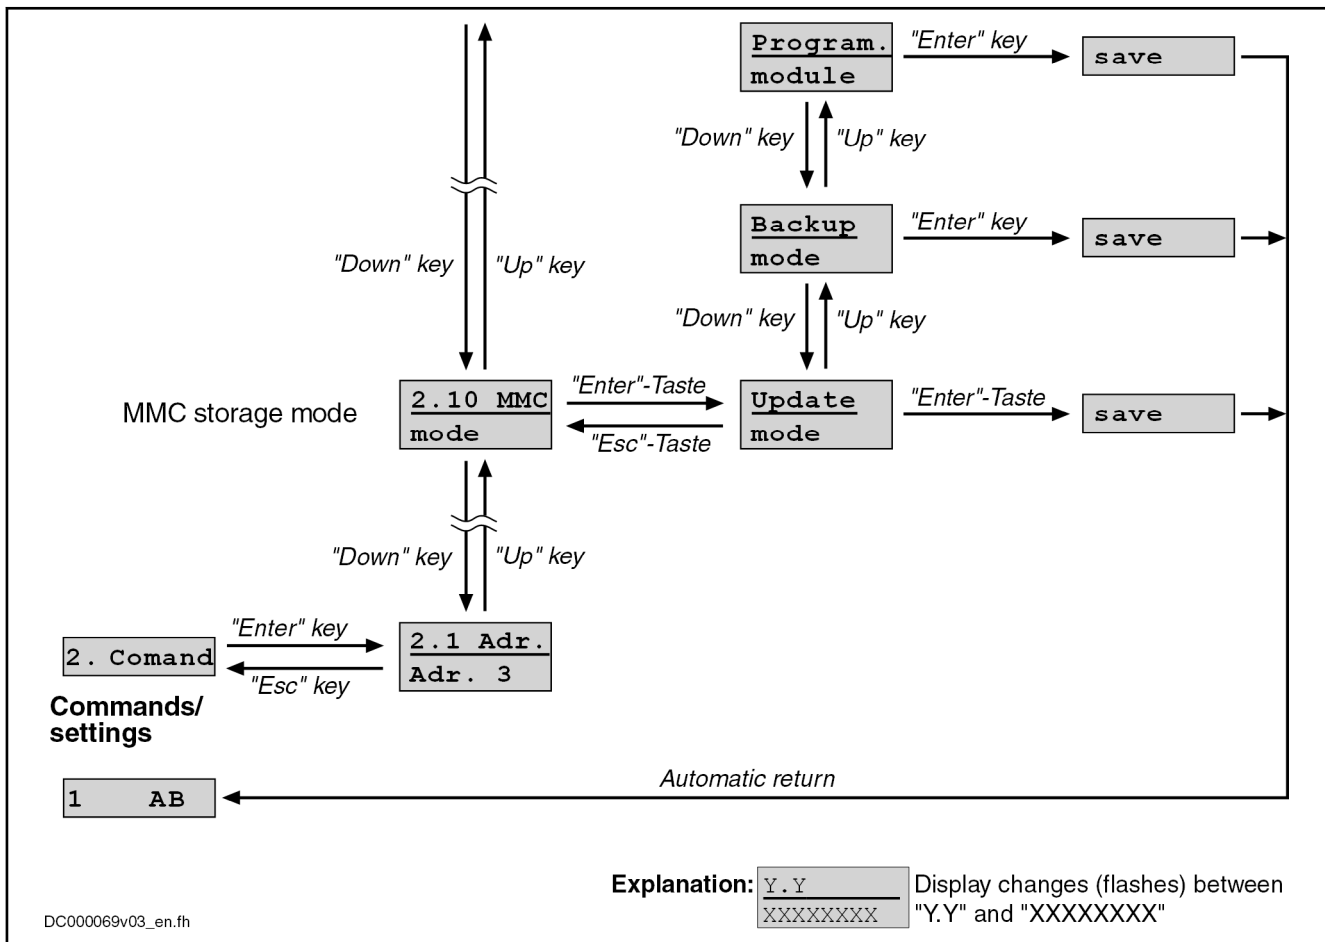
Fig.4-26: Setting the MMC Storage Mode With the Control Panel

The options for using the MMC in the IndraDrive controller are described in detail in the section "MultiMediaCard (MMC)".
